Management of Occurring Threats to Wooden Monasteries in Mandalay: A Case Study of Maha-Minhtin Monastery

Mary Oo¹ and Thet Oo²

¹Department of Architecture, Mandalay
Technological University, Myanmar

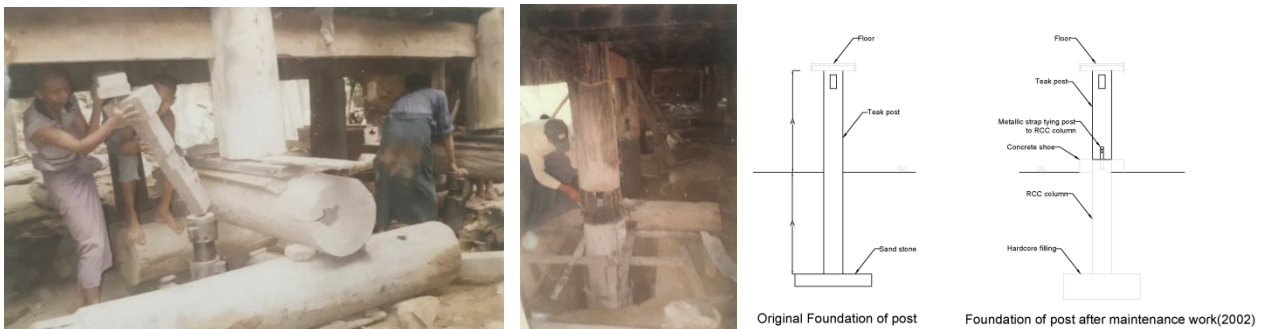
As the first step, the water under the monastery was pumped out, which addressed the main problem. Then, it took time to dry the ground and return to its original state. The second step is that during the waiting period, the damaged roofs, walls, wooden floors and doors were systematically removed, and a temporary building was constructed to house them. The building was straightened out as a start when the soil from the floodplain returned to its original state for the third step. In that case, jacks were used to raise all wooden posts to the same level. Out of those posts, the non-reusable posts were replaced with new wooden ones. After that, the decomposed wooden posts in the ground were cut and replaced with reinforced cement concrete (RCC) round columns and attached to the remaining original logs. About one foot of hardcore was laid at the bottom of the RCC columns. The original type of foundation of the monastery, progressive steps for lifting wooden posts with jacks and building RCC columns are shown in photo records below.

Fig. 5 Lift wooden post with jack, connection between wooden post and RCC column and types of post foundation. Source: The first two photographs are taken by Department of Archaeology and Museum, 2002 and the last one is drawn by author, 2022.

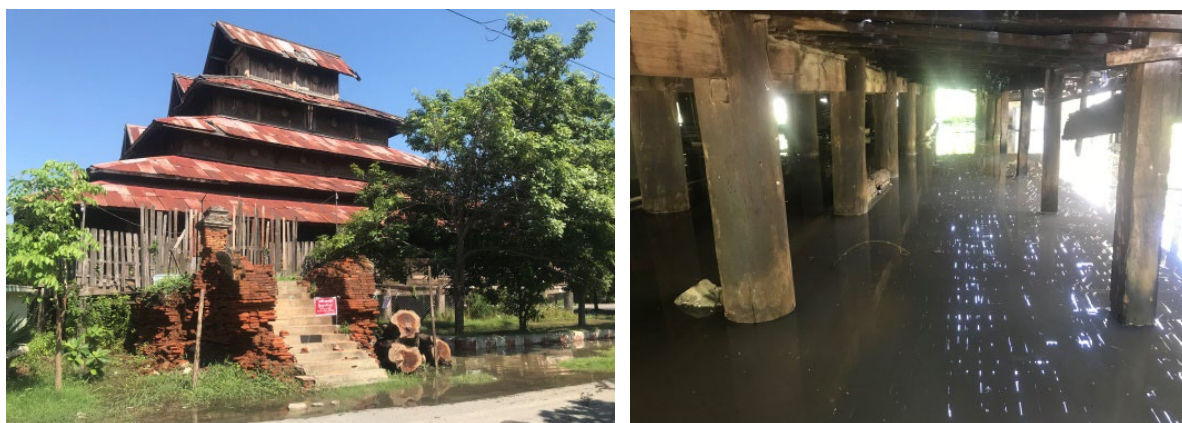
Maha-Minhtin monastery is located in the Maha-Minhtin monastic compound. It is also called the central monastery because it is in the middle of the compound, surrounded by 15 other monasteries. As mentioned earlier, the Maha-Minhtin monastery is slightly lower than the surrounding land, so when it rains, the water accumulates here. In addition, drainage ditches are located outside of the monastic compound. The canal dug near the Maha-Minhtin monastery in 2002-2004 was a pool made for aesthetic purposes only, which did not connect to any drainage. Therefore, during the rainy season, the pool overflows and floods under of the monastery. In such cases, it can take up to three months for the water under the monastery to dry up and the ground to return to normal. The rainy season in Mandalay runs from May to October. The heaviest rains are in August with an average of 28.8 days and typically up to 6.69” for that month (Weather Atlas 2021). During such rainy months, the base of the monastery and its surroundings are covered with rainwater all the time. The following shows records of Maha-Minhtin monastery being flooded in October 2021 due to heavy rains.

Fig. 6 Flooding around and under Maha-Minhtin monastery. Source: Photo by author, 2021.

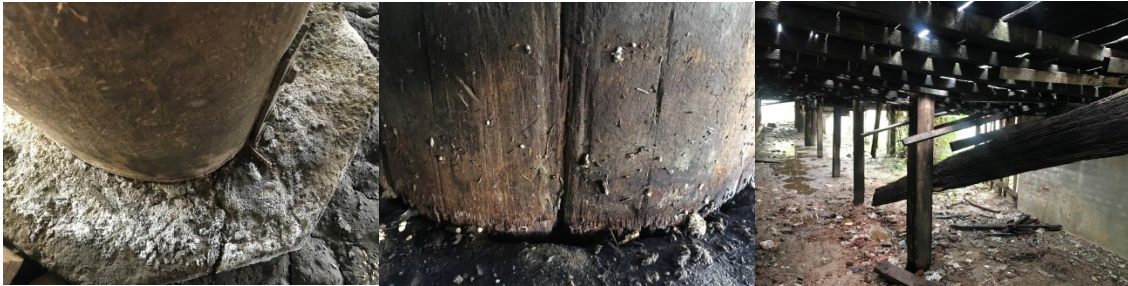
This is the most threatening issue for the building. On rainy days, water seeps under the monastery to a depth of 1.5 feet. The floodwater not only submerged the concrete shoes at the bottom of the wooden posts but also flooded the upper posts of the concrete shoes up to 6 inches. There are concrete shoes and RCC short columns at the bottom of the wooden posts that support the building, but no concrete shoes and RCC short columns under the posts that support the veranda around the building exist. Because of that, after the rain, the soil is moist and not as hard as usual and the wooden posts in the veranda on the north side of the building often collapse. On the night of 30 October 2021, heavy showers of rain caused the posts on the walkway to collapse. As a result, the columns became uneven and the main beam carrying the loading of the floor collapsed, and the floor was damaged. In addition, the area under the monastery is not exposed to direct sunlight and has poor ventilation, so it takes a long time for the soil to return to its original state after flooding.

Due to floodwater caused by heavy rains on the night of 30 October 2021, the ground beneath the monastery did not dry up until the end of January 2022. It was such soil moisture that fungi can grow on concrete shoes and wooden posts, and ants and termites are infesting the wooden posts. The above-mentioned incidents are aftermaths of the flooding of wooden posts because of water accumulation under the monastery due to heavy rains. The situation is illustrated with the images below.

Fig. 7 Fungi on concrete shoe and wooden post, and the condition of main beam under the veranda floor. Source: Photo by author, 2022.

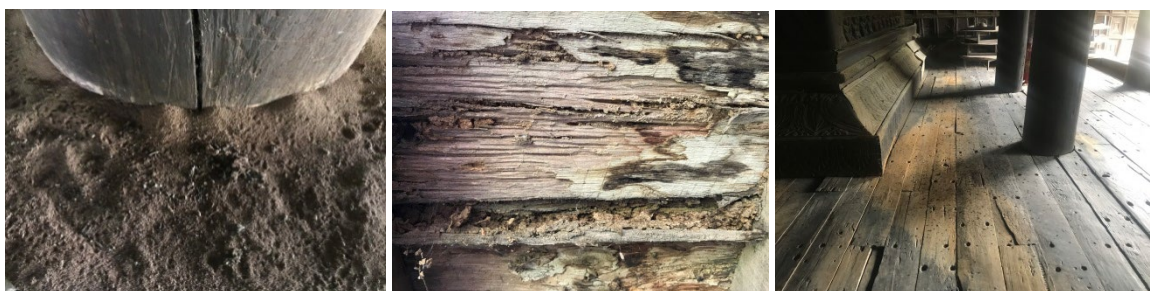
The second most dangerous issue of natural threats is from animals and plants. During the rainy season, when the foundation is flooded and the moisture of the wooden posts and the ground is high, the termites and ants consume the wood and make bores. Then, they make anthills and nest in the wood bores. There are nests of the termites not only in the wood bores but also in the highly humid wooden veranda floors. There is not any harm caused by these insects in the interior space where the moisture is low. The parts with the maximum damage from these insects are the lower part of the wooden posts and the veranda floors with constant exposure to water.

Fig. 8 Damage of wooden post, veranda floor and interior floor caused by animals. Source: Photo by author, 2022.

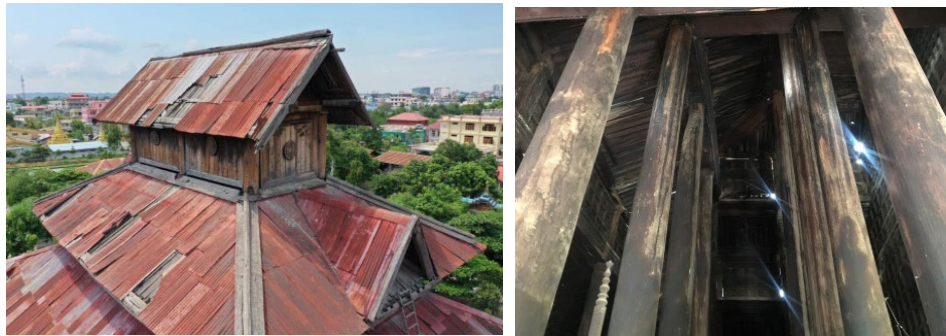
Strong winds can cause damage to the roof. When studying the roof of the building, it is seen that the south side of the roof in the windward direction is more damaged. Currently, the roof is covered with corrugated galvanized iron (CGI) sheets, and the original timber roof structures are found below it. The depredation allowed rainwater to seep into the building and damage the floors. Furthermore, there is leakage of rainwater through the connection between the roof and the wooden posts where rainwater is flowing along the posts. Due to the rain leakage, although the wooden floor and posts inside the building were damaged, about 70% have not yet been destroyed. However, if the roof problem is not solved in time, there is a risk of damage in the short term.

Fig. 9 Damage roof, and the flowing markings of wooden posts caused by weather. Source for the first photo: <https://www.facebook.com/100002313436951/posts/3291084617645287/?d=n>, Zay Myo Lin, 4 September 2020, sharing about the main problem of Myanmar wooden monasteries, and second photo by author, 2022.

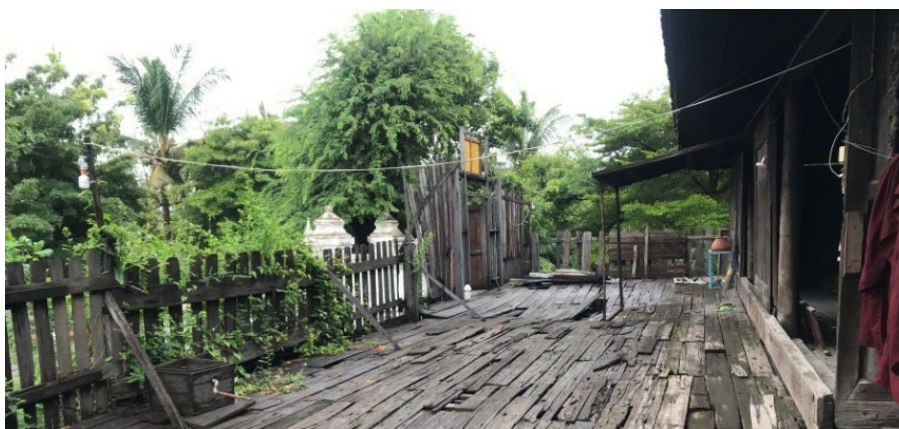
Outside the building, the circuit is not supported with a cover and roof. 90% of the veranda floor was damaged due to weather and water use in the monastery. In addition, the wooden posts supporting the veranda are very weak because they have sunk due to the constantly wet soil. Moreover, when all the posts that mainly support the monastery are examined, it is found that the outermost posts are more damaged on account of weather. The figure below states the condition of the veranda floor as seen today.

Fig. 10 Condition of veranda floor. Source: Photo by author, 2022.

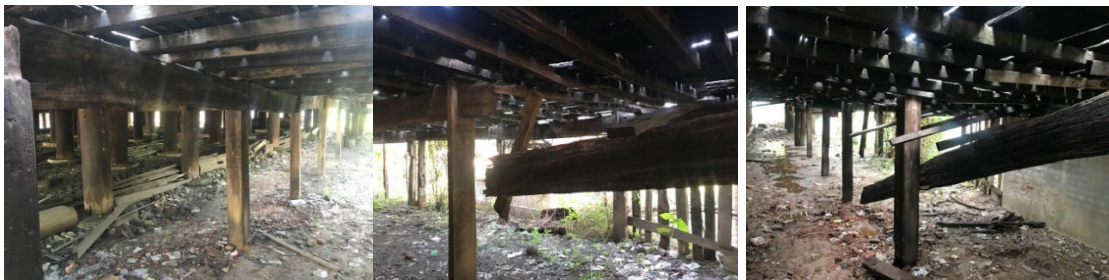
As reported earlier, this monastery was the largest in Mandalay during the Konbaung era and was made up of four apartments. Due to deterioration, only one of the apartments remain. The remaining apartment was also maintained in 2008-2009, but there is no maintenance at all at present. The photographs below show a slightly deteriorating situation in a short period due to such routine maintenance failures.

Fig. 11 Condition of main beam under the north veranda in January 2020, in October 2021 and in September 2022. Source: Photos by author.

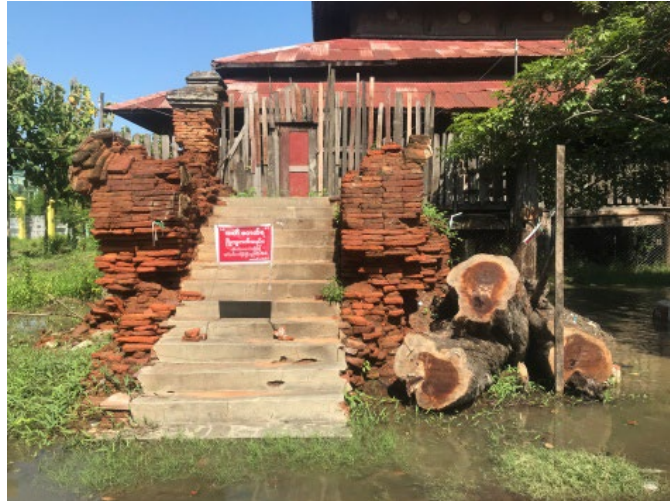
There were originally four staircases leading to the remaining main apartment. However, the staircase situated in the southeast has been wholly destroyed due to flooding, rain, and lack of routine maintenance. The southwest staircase is part of the original structure and now 80% of it is ruined. The staircase to the northeast of the building is not original handiwork but is remodeled. These staircases are not only an important significant architectural feature of late Konbaung monasteries, but also a component that reinforces the strength of the building. Despite being such an important component, currently not only its original architectural features but also its structural strengths are lost.

Fig. 12 Staircase at the south side of Maha-Minhtin monastery. Source: Photo by author, 2021.

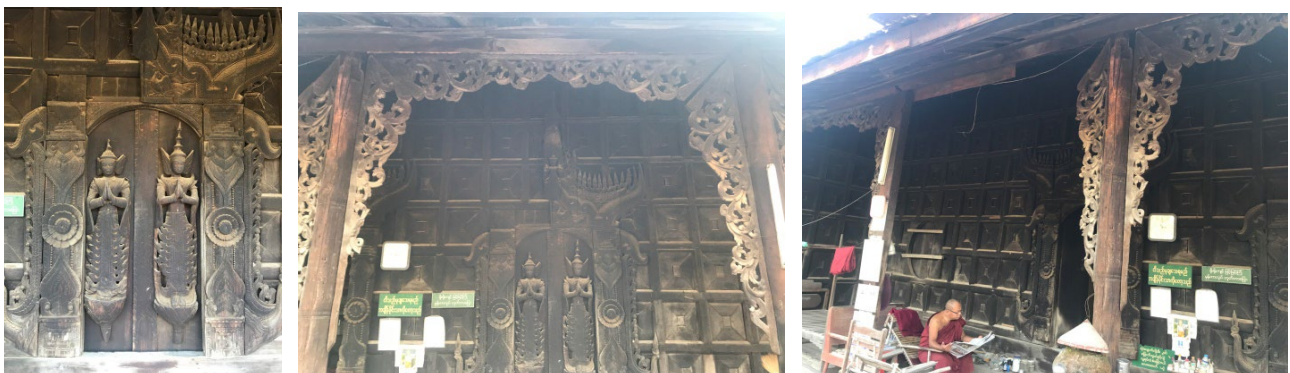
When examining the exterior architectural conditions of the Maha-Minhtin monastery, the lack of handrails of the veranda stand out as they are lost. At the time late Konbaung wooden monasteries were constructed, the handrail designs and adornments were always decorated depending on the status of the donor, as a customary rule. The design of the handrails of the monastery donated by the King and the chief queen and adornment designs included in that donated by the royal staff are not allowed to be the same. Due to these rules, the status of the donor can be estimated by looking at the handrail designs of the late Konbaung period wooden monasteries. In this way, the complete disappearance of the original veranda handrails artifacts has reduced the architectural value of the monastery. In addition, some parts of the wooden floral barge-boards between the two posts supporting the roof edge of the main building were broken or damaged, and some have completely disappeared. In addition, about 90% of the wooden sculptures which are decorated at the entrances that can be said to be a significance of the late Konbaung monasteries has already been lost. Therefore, it can be considered that the original characters outside of the building face worrying situations. The above damage and problems are due to the weather and lack of routine maintenance. The pictures below state the current situation of exterior architectural features of Maha-Minhtin monastery.

Fig. 13 Current situation of exterior architectural features. Source: Photos by author, 2020.

Along with repairing the floor in the veranda, the handrails should be restored to their original handiwork. The handrails that are now visible seem to be plain and graceless and should be reconstructed in accordance with the characteristics of the monastery donated by the King's servants at the time. The approaching staircases also need repair along with the veranda works. The staircase to the south of the building is original but quite damaged. It is important for it to be reconstructed according to the original design of the staircase. The two staircases on the north side of the building should also be repaired in accordance with the original design. In addition, damaged roofs that weaken the physical strength of the building must be replaced. The roof structures under the roofing sheets must also be inspected in detail. The above-mentioned conservation work should be carried out in the dry season. After that, wood floral motifs and wood sculptures that enhance the value of the building need to be maintained after the necessary repairs for physical strength have been made. The wood floral motifs and sculptures are often left untreated for years and has accumulated dirt over time. These impurities cause harm to the original appearance of the wood carvings. When cleaning these contaminants, only non-destructive methods must be used. Wood carvings that were destroyed and lost must be replaced and restored like their original appearance.

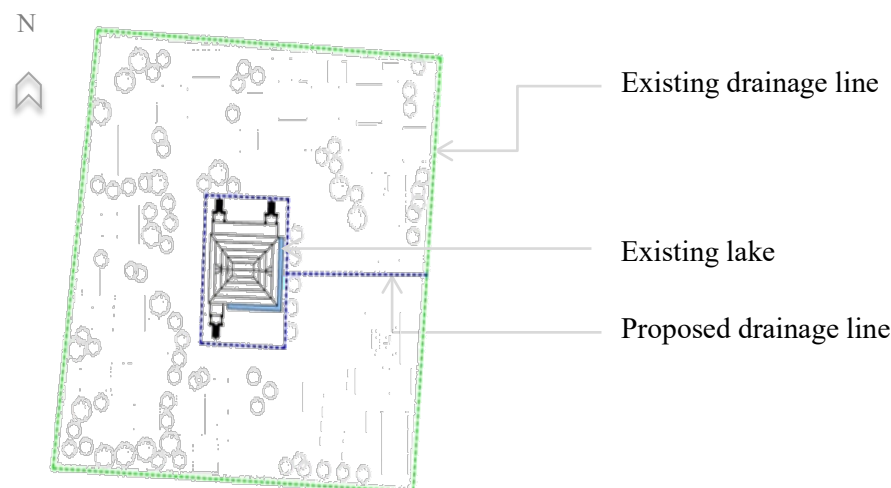
Fig. 14 Plan of existing and proposed drainage line. Source: Drawn by author, 2022.

The threats existing for a long time in Maha-Minhtin monastery is flooding. It needs to be solved as a priority. The main source of flooding comes from the poor drainage system and happens due to the lower ground surface than the surrounding environment. Therefore, the first step is to create a drainage line around the monastery and connect it to the pool outside the campus of Maha-Minhtin monastery. The existing drainage line is about 200ft from the Maha-Minhtin monastery that is about 1.5 feet wide and 2 feet deep. It is clogged with garbage in the rainy season, resulting in poor water flow and the rise of water levels. As such, this drainage line should also be systematically upgraded. After that accomplishment, it should be connected to the proposed drainage through underground pipes to prevent visual and waste pollution. The connection plan of the drainage line outside the campus, the proposed drainage around the building and existing lake is presented with the following drawing.

When it rains, a perforated pattern cover design for the proposed drainage line will be used to allow rainwater from the surrounding area to enter it. It connects to the drain line outside the campus with a 0.25"/ft slope. As the slope of proposed drainage is 0.25", the drain will be about four feet underground to meet the existing line. Therefore, the existing drainage must be upgraded to be

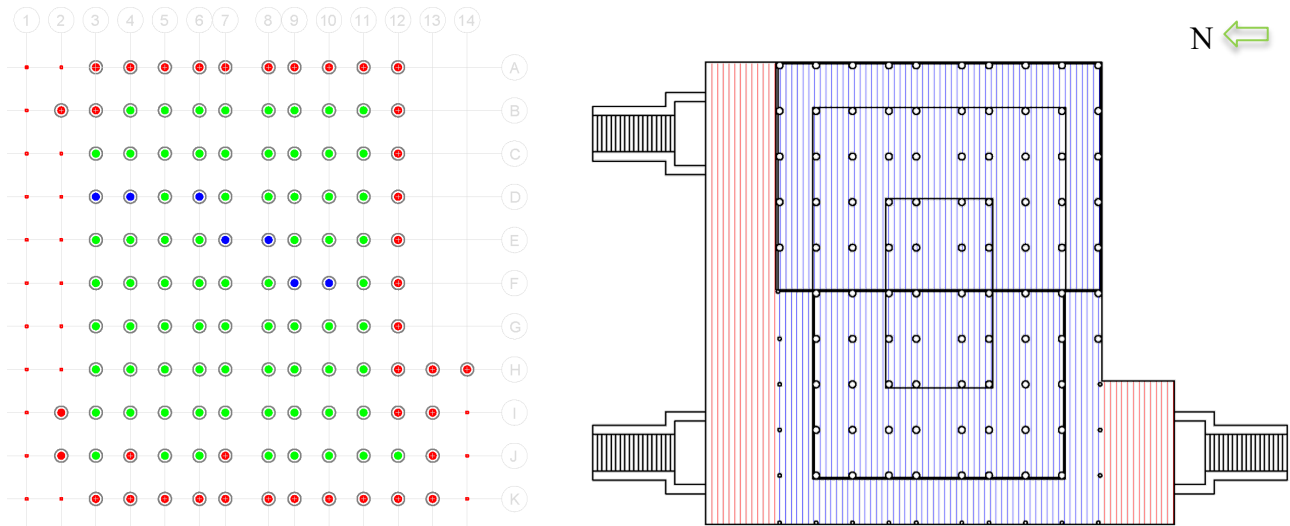
Fig. 15 Wooden posts and floor plan. Source: Drawn by author, 2022.

Name	Current Condition	Remark	Photo
A-3 to 12 B-2, 3 and 12 C-12 D-12 E-12 F-12 G-12 H-12, 13 and 14 I-2, 12 and 13 J-2, 4, 7 and 13 K-3 to 13	Crack line from top to bottom under the floor of the building	Replacement required

As a second step, the strength of the wooden posts supporting the veranda must be inspected and replaced with new ones. Moreover, the posts should be reinforced with underground RCC columns to prevent subsidence as before. Then the ruined timber beams and flooring in the veranda must be totally replaced. The following drawing and table show the current damage level of wooden posts.

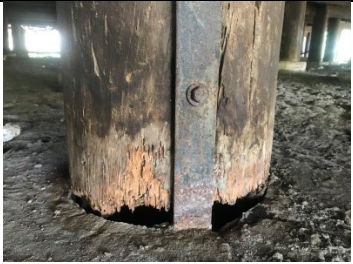
(Current condition of F-10.)
Green posts	Fair condition With fungi and ants	Need to preserve Need to remove the ants and fungi	
Red floor	Not easy to walk on Low quality wood With termites	Replacement
