Did earth move to fell Angkor?

Dr Heng Thung, a geologist who has been studying aerial photographs and satellite imagery, provides compelling interpretations from the perspectives of hydrology, geology and topography

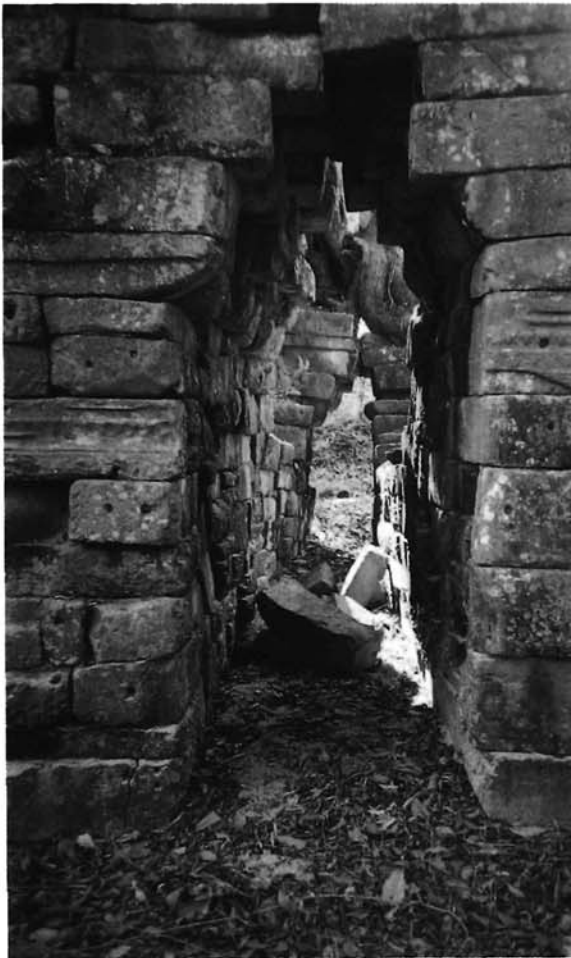
Original arch of stonebridge, east of Angkor Thom

mately two to two-and-a-half metres deep when it was dug some eight centuries ago as indicated by the old stone bridge, the footing of which lies two-and-a-half metres below the water surface (over which the water would flow). However, the new river bottom is now about six metres deeper due to erosion, and the canal depth decreases downstream, levelling slowly to the original depth of two metres further down beyond the city of Siem Reap. This is a reliable gauge of the amount of down-cutting which took place since the bridge was breached.

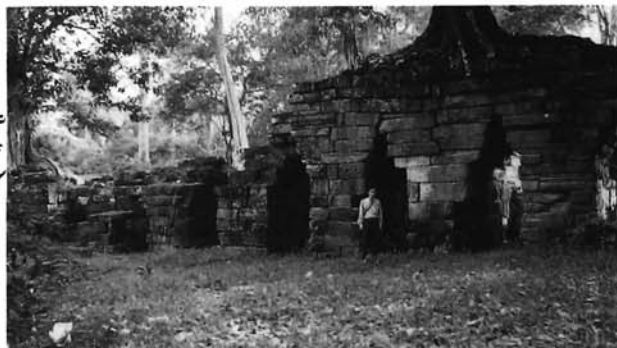
Looking south, this diagram shows the previous dry season water level, the present down-cutting and the breach on the left.

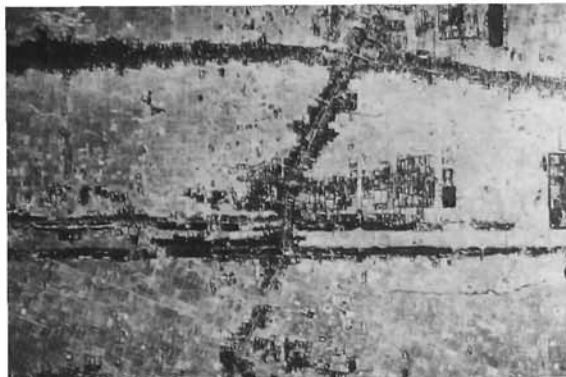
A vertical aerial photograph of the Prek Thnal Dak shipping canal.

The Prek Thnal Dak canal thirty kilometres east of Angkor runs north-south for approximately twenty-eight kilometres from the present lake shore during the dry season. The difference of elevation between the two points is twenty metres, indicating a significant degree of upward shift. This difference in elevation is not necessarily the same as that of Angkor, as there are

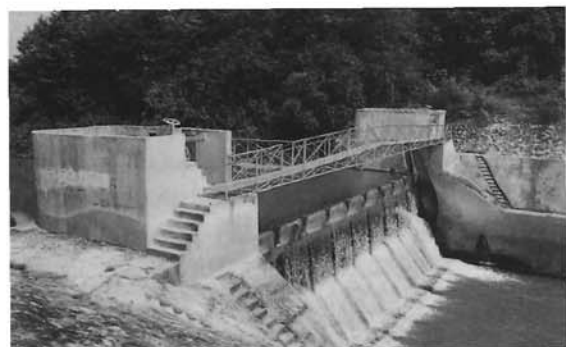
Upgraded French dam raises the water level in the canal to allow the water to enter through the old intake and fill the West Baray, which has been converted to a modern irrigation reservoir.

When French engineers rehabilitated the reservoirs, they built a dam across Siem Reap, effectively raising the water level to bring water into the West Baray. This is by far the simplest and most logical method of rehabilitation, but without the knowledge that the French engineers had of clay core dam construction, the Khmers could not have accomplished such a task.

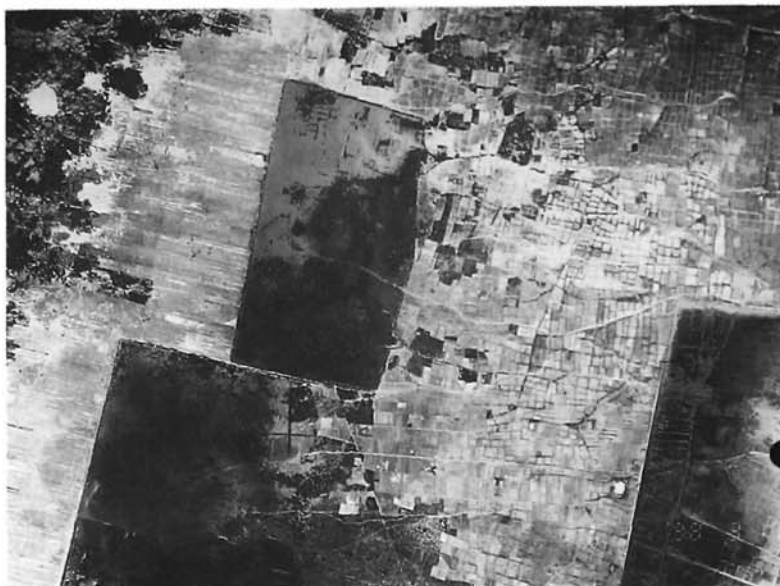
The technique of flooding the dike-enclosed reservoirs during the rainy season is currently still being practiced along the north shore of the Tonle Sap Lake and the Mekong River floodplain north of Phnom Penh.

were derived from the original agricultural system of impounding flood waters within diked enclosures. This system is still practised throughout the areas that are flooded annually by the waters of the Mekong river, including those surrounding Tonle Sap Lake.
