CHEMICAL COMPOSITION OF STUCCO IN SUKHOThai 'S MONUMENTS

A Preliminary Report by
Mr. Sirichai Wangchareontrakul,
Chemist Conservation Laboratory,
Museum Division,
Department of Fine Arts, Thailand

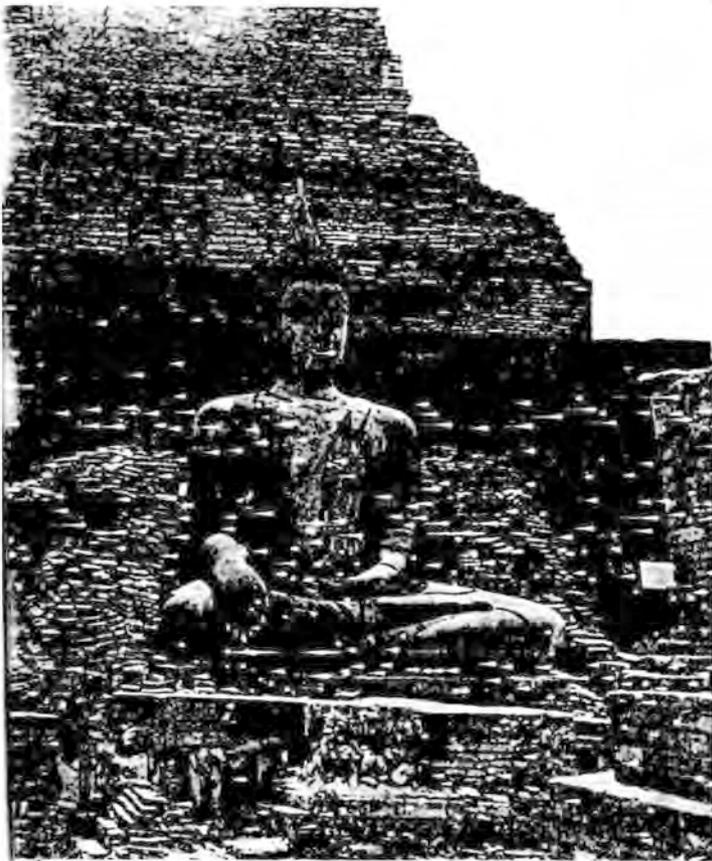
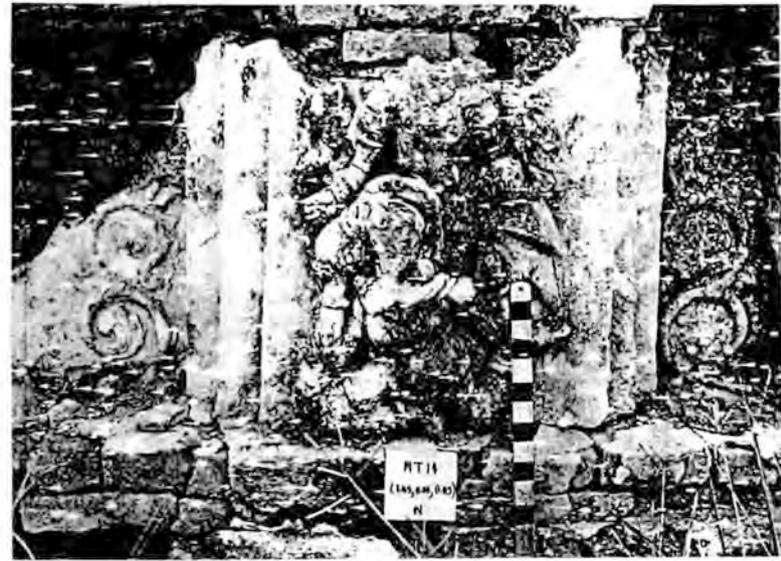
Fig 1-2
The first chedi in Wat Mahathat that was selected for taking samples MT3-MT16.

1. Twelve stucco samples from twelve places have been collected from two chedis in Wat Mahathat which is the largest temple of Ancient Sukhothai. Four samples from the first chedi were taken from the fifth terrace on the east side, (MT3) in Table 1, north side (MT4), south side (MT6) and west side (MT8). Samples MT13; MT14, MT16 and MT18 were taken from the north, west, south and east side of the small wall surrounding the chedi.

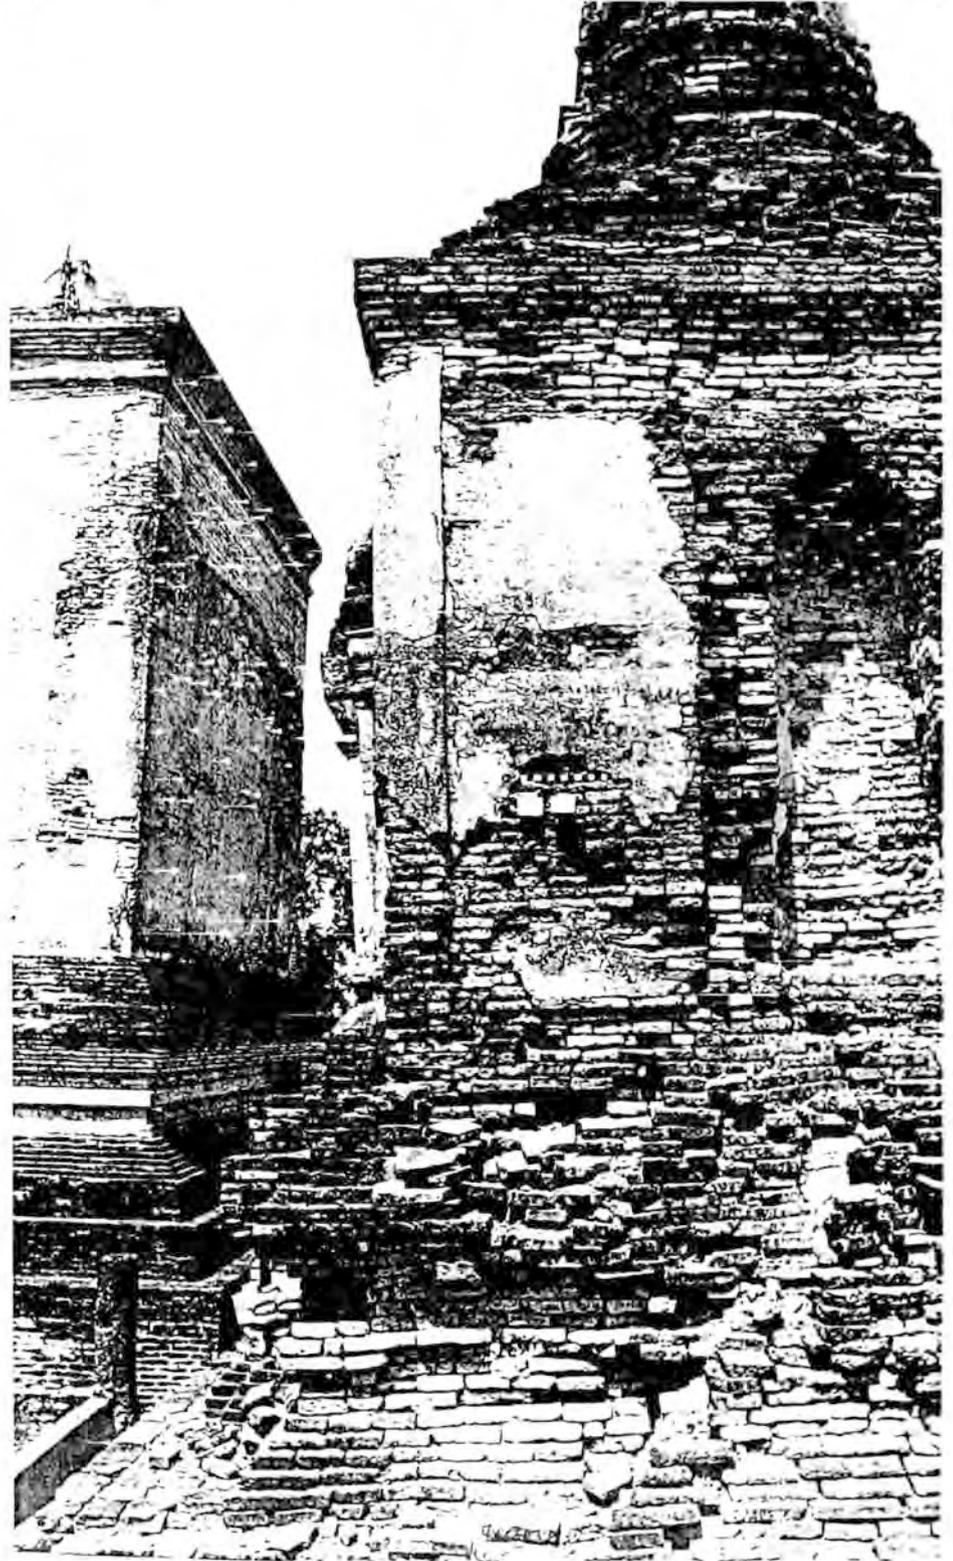
Fig 3
The second chedi in Wat Mahathat that was selected for taking samples MT 20-MT 26.

The other four samples (MT20, MT22, MT24 and MT26) belonging to the second chedi were collected from the south, east, north and west side of the chedi.

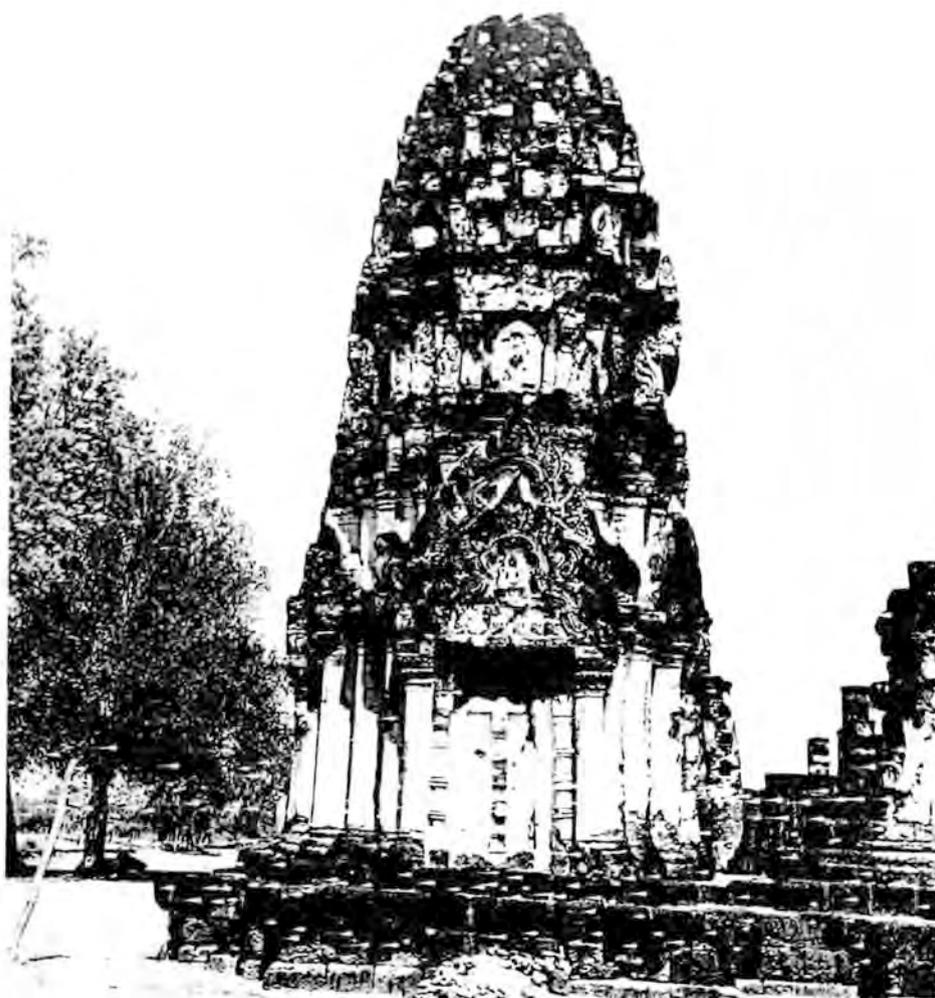
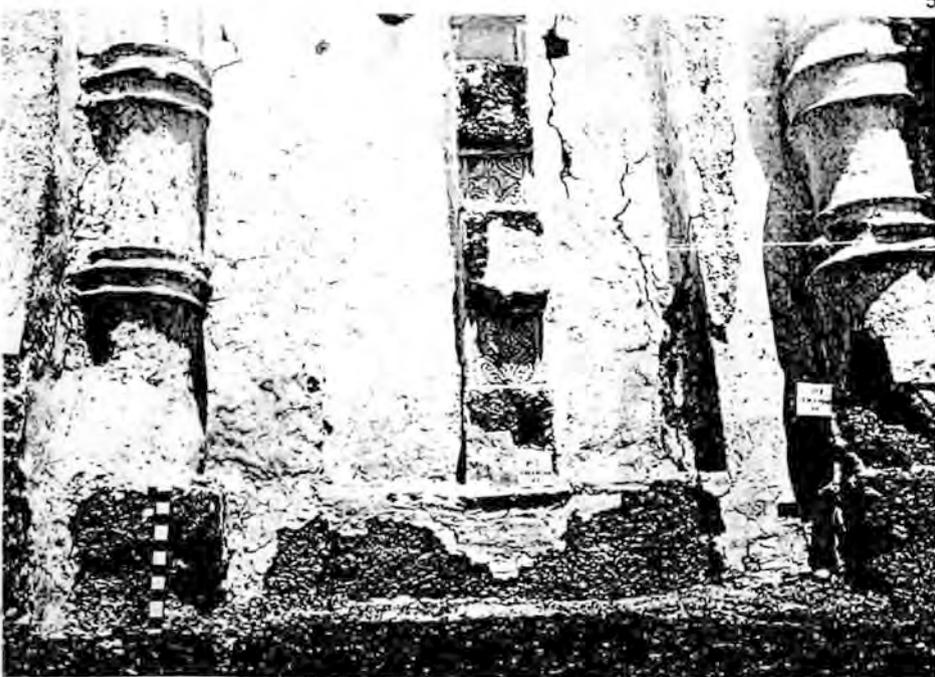
Fig 4-5
The northern prang decorated with stucco figures in Wat Phra-Phai-Luang.

2. Ten stucco samples have been selected from the northern Prang decorated with stucco figures in Wat Phra Phai Luang which is second in importance to Wat Mahathat.

Samples P1, P2, P3, and P4 in Table 2 were taken from the western side and samples P5, P6, P7 and P8 were taken from the south side. Sample P9 was on the east side and the other one (P10) was collected from the north side.
