CONSERVATION OF ANCIENT STUCCO

The stucco ornamentation in Wat Nang Phaya

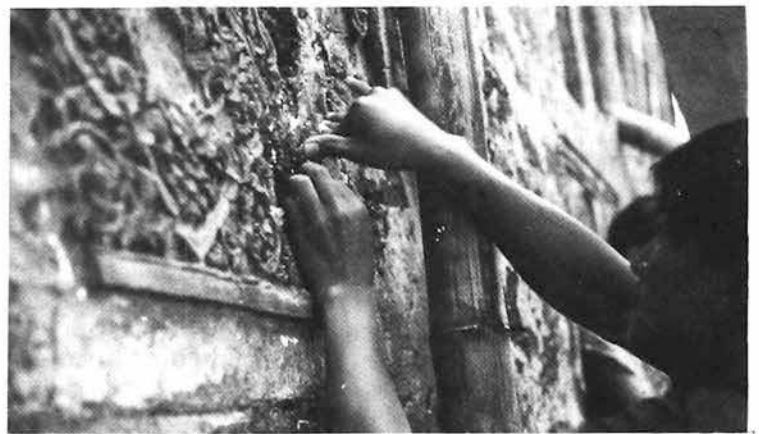
The broken pieces in the design are joined using paraloid B72.

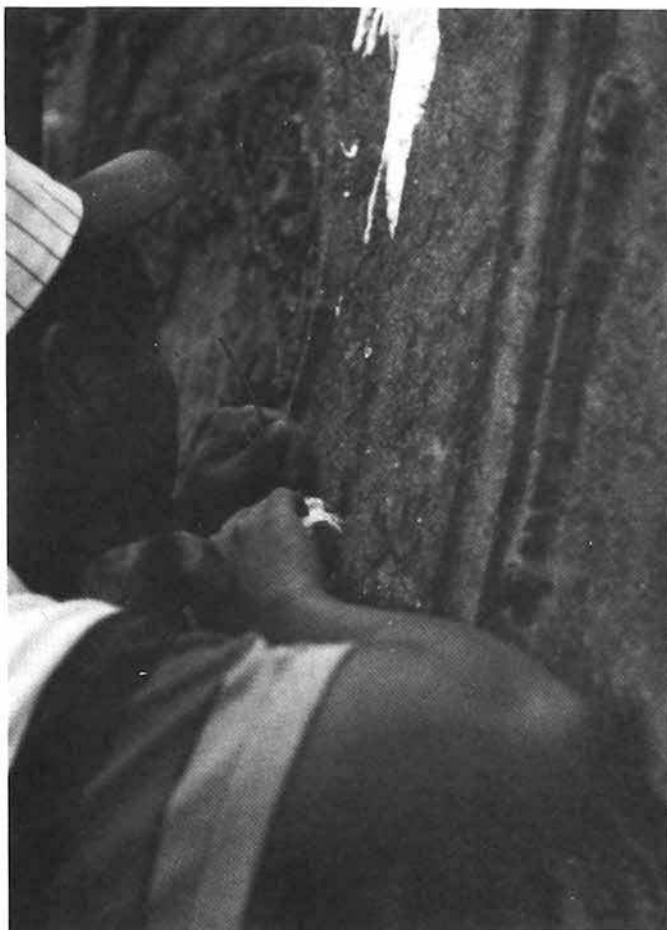
1

1. The conservator uses silicone rubber to make moulds.

The condition of the temple prompted the Fine Arts Department to execute conservation work. It proceeded using the following steps: all details of the ornamentation were recorded before the cleaning process began. Excess dust and grime were cleared using a soft dry brush. Then the surface was brushed again and washed with distilled water. When it was already dry, a solution of 5% paraloid B72 in acetone was sprayed. This served to consolidate the stucco as the solution penetrated its porous sections and held them together. Finally, when the stucco was strong enough, moulds were made using silicone rubber (silastic ERTV). These were used in restoring missing designs.

Looking back, they also discovered that it would have been better to use photogrammetry, rather than moulds, in replicating the designs. Certain parts of the ornamentation had extremely intricate designs which did not appear in the moulds and were easily destroyed as the latter was removed.

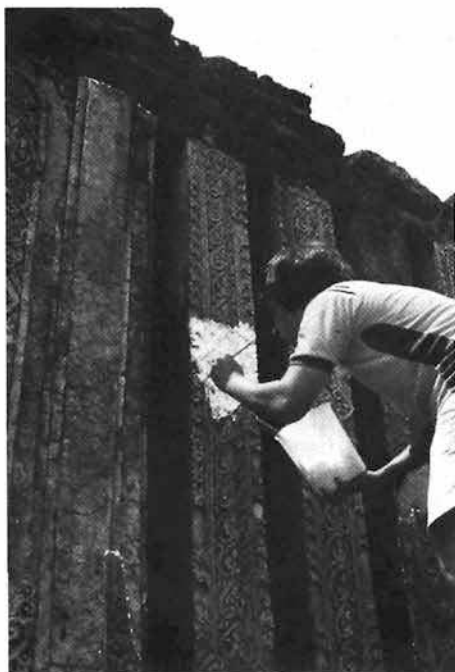
2

2. Extreme care is required in duplicating the design.

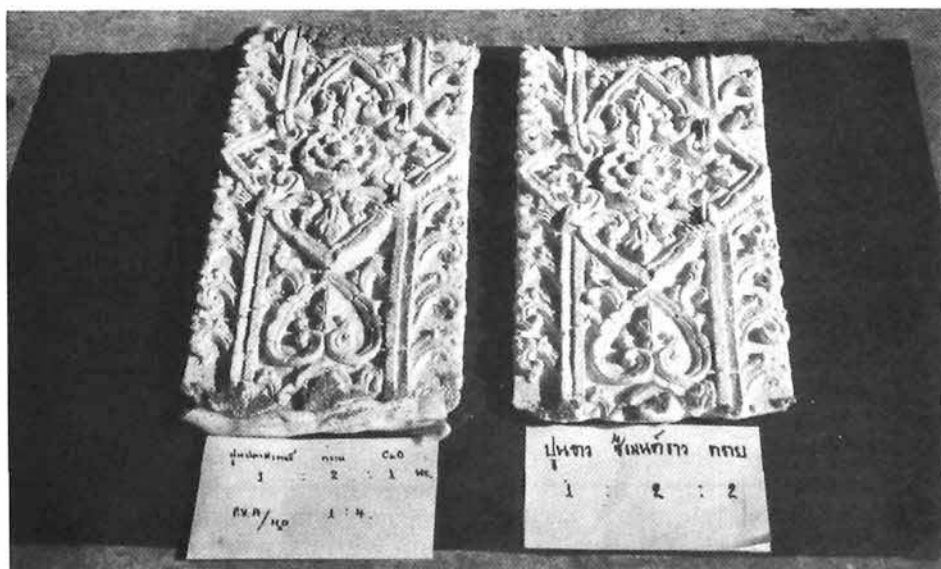
3

3. Reproductions of a stucco panel
