Analytical Chemistry Methods of Estimating the Hydraulic Lime Characteristics of Mortars from a Spanish Colonial Period Fortification in the Philippines: Perspective of a Southeast Asian Country

Jan-Michael C. Cayme
Chemistry Department, De La Salle University
Manila, Philippines

Abstract

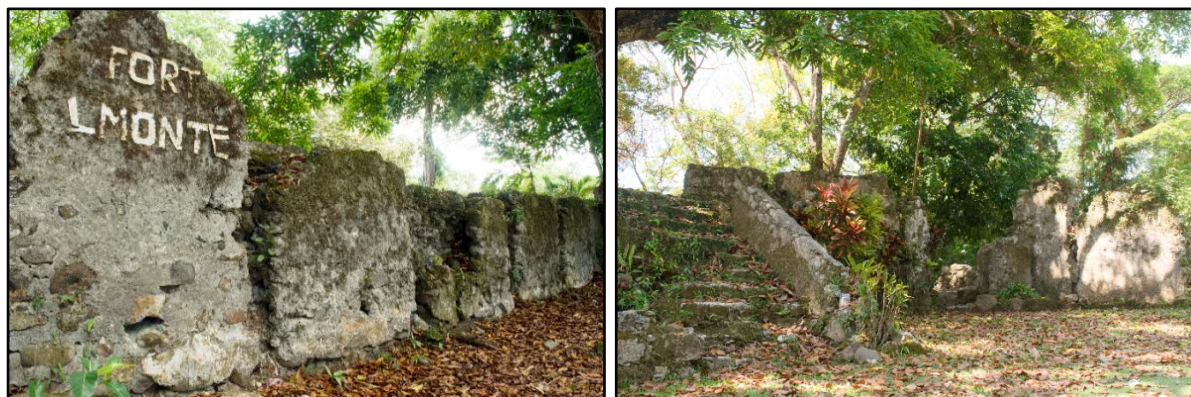
Fig. 3 Fort Almonte within the Liangan East Elementary School, Bacolod, Lanao del Norte. The outer front wall (left) and the inside wall portion (right) view. Source: Photo by JM Cayme, April 2015.

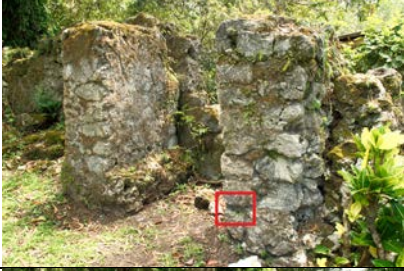
Mortar Code	Mortar Type	Sampling Area	Approximate Sampling Location
FA-1	Joint mortar	Western side of the fort. Inner wall column.

Table 1 shows the lime mortar samples obtained in 2015 from selected portions of Fort Almonte and labelled as FA-1 and FA-2. The pieces were carefully removed between the joints of the coral stone walls using a chisel to obtain a total mass of approximately 2.0 grams each. These amounts were sufficient to perform the EDXRF and TGA analysis needed for this study and minimal enough to preserve the historical fabric of the structure. Upon collection, the mortar sample portion facing the exterior part, which is contaminated by the surroundings, was discarded to prevent conflicting information from the analyses. A closer inspection of the sample’s physical properties confirms that it is made of old lime mortars and not modern-day cement.

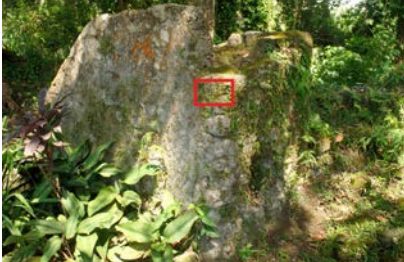
FA-2	Joint mortar	Southern side of the fort. Back portion of the stairway.

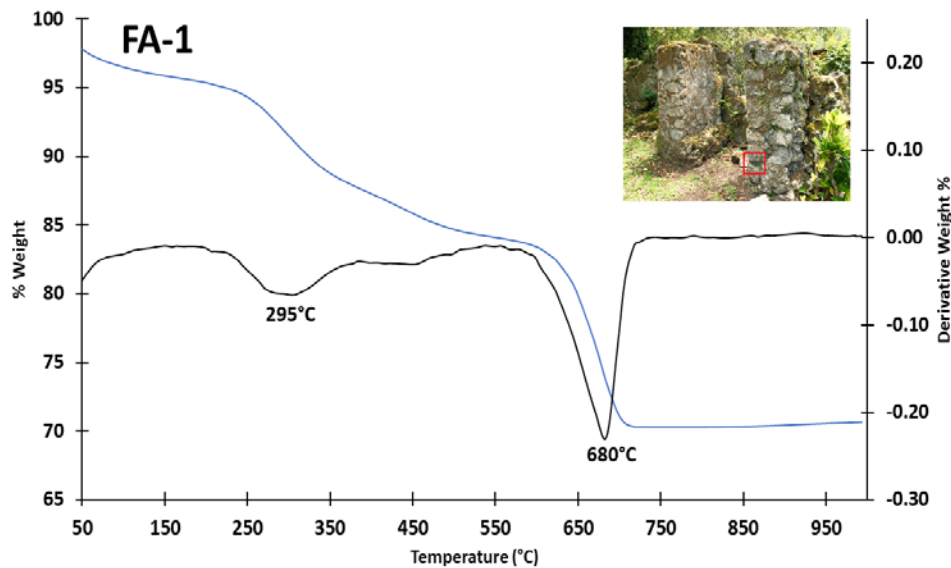
Fig. 4 TGA thermograph of FA-1 (blue line) including the 1st derivative plot (black line). Two significant weight losses were recorded, at 295°C and at 680°C (maximum).

time and dehydration of gypsum are also eliminated (Cayme and Asor Jr 2016). Table 3 shows that FA-1 (3.80%) exhibited a higher weight loss until 120°C, compared to FA-2 (0.26%), which means that FA-1 has absorbed more water than FA-2. A possible explanation for this observation is FA-1's location, which is situated near the ground and has soaked up more water over time. Within the temperature range of 120°C to 200°C, both samples roughly have a similar weight loss pattern at less than 1.0%.

Structurally bound water on the surface of hydraulic mineral phases such as calcium-aluminum-silicate-hydrates or calcium-silicate-hydrates evaporates between the range of 200°C to 600°C. Impurities from organic compounds are also combusted at this temperature range (Ingo et al. 2004). The loss of weight of FA-1 is almost twice that of FA-2 and is evident from the TGA thermograph in Figure 4, showing a significant weight loss centered at 295°C. This observation is supported by the EDXRF data (Table 2), where it is observed that FA-1 has a higher LOI value, and the ratio of calcium and silicate is also more significant compared to FA-2. Thus, it can be assumed that FA-1 has more hydraulic clay minerals where the water can attach, and organic contaminants are more present due to the unaccounted LOI values, which can come from carbon compounds. A considerable drop in the mortar's mass happened within the range of 600°C to 850°C, attributed to the decomposition of CaCO₃. These patterns are characteristic of lime as the CO₂ is removed and typically originates from a recarbonated mortar (Moropoulou et al. 1995b). The maximum weight loss of FA-1 occurred earlier at 680°C, while for FA-2 at 793°C. The early decomposition experience by FA-1 is due to the dehydroxylated clay mineral illite present in the mortar during the calcination of lime. These dehydroxylated clays are responsible for providing strength to the mortar (Moropoulou et al. 1995a).

Furthermore, the CO₂/H₂O ratio from the thermograph is useful for classifying the extent of the binder's hydraulic nature. The ratio corresponds to the weight loss greater than 600°C (i.e., CO₂) and the temperature between 200°C to 600°C (i.e., hydraulic H₂O) (Moropoulou et al. 1998). The computed CO₂/H₂O ratio is seen in Table 3, where FA-1 is 1.06, and 5.15 for FA-2. Since these ratios are less than 6.0, both are classified under the hydraulic lime mortars group. The typical weight loss patterns further affirm this assumption for the hydraulic H₂O, which should be above 3.5%, and a CO₂ value of below 30%, for hydraulic mortars (Maravelaki-Kalaitzaki et al. 2003; Moropoulou et al. 2005). FA-1 and FA-2 also met these conditions. FA-1 can be classified further under the subgroup pozzolanic and portlandite mortar due to CO₂ weight loss values between 10 to 20% and a CO₂/H₂O ratio value below 3.5 (Moropoulou et al. 2000). The pozzolanic property most likely came from clay as the binder is heated from 400°C to 600°C. It is not surprising that clay is part of the production process because the province of Lanao del Norte, specifically Bacolod, has a sandy-clayey soil type (Province of Lanao del Norte n.d.).

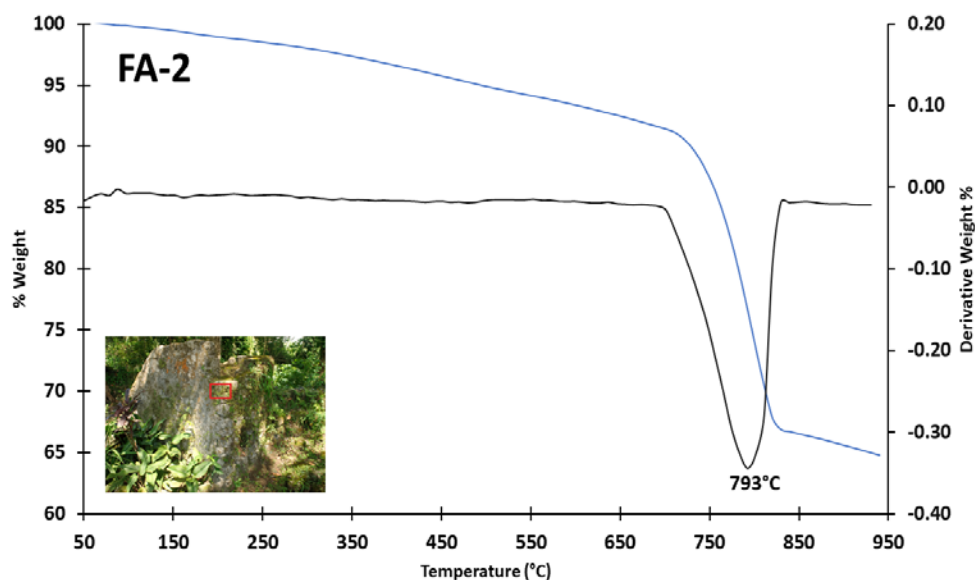
Fig. 5 TGA thermograph of FA-2 (blue line) including the 1st derivative plot (black line). Maximum weight loss was recorded at 793°C.
