Management of Occurring Threats to Wooden Monasteries in Mandalay: A Case Study of Maha-Minhtin Monastery

Mary Oo¹ and Thet Oo²

¹Department of Architecture, Mandalay
Technological University, Myanmar

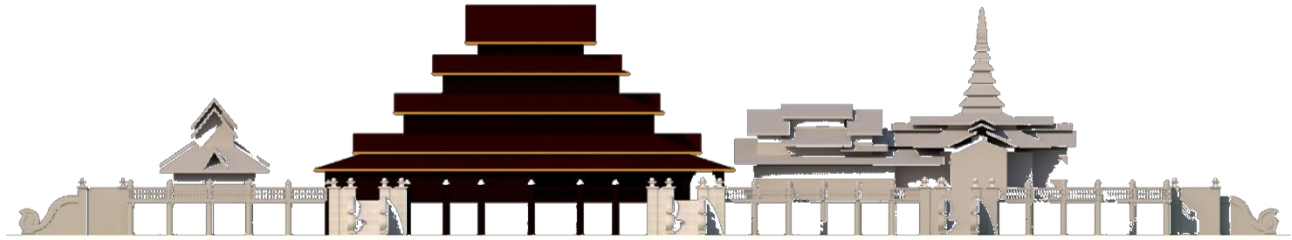
Fig. 4 An outline drawing for remained and disappeared parts of Maha-Minhtin monastery. Source: drawn by author, 2022².

Its roof has five stories and many of the late Konbaung-era architecture remains. But because of lack of maintenance and poor maintenance methods, high-value wooden artifacts are now being damaged in a short period, and the structural frames of the building are deteriorating. When studying the records of continual maintenance, it is observed that the building was repaired and maintained only three times, for the first time in 2001-2002, second in 2002-2004 and third in 2008-2009.

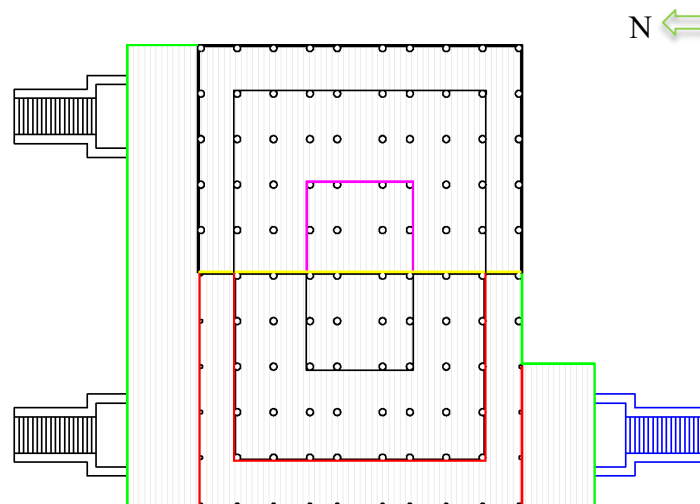
Fig. 16 Location of veranda handrails, wood carvings and staircase. Source: Drawn by author, 2022.

Name	Current Condition	Remark	Photo
Veranda Handrail (Green Line)	Totally lacking in the original character	Replacement required

Along with repairing the floor in the veranda, the handrails should be restored to their original handiwork. The handrails that are now visible seem to be plain and graceless and should be reconstructed in accordance with the characteristics of the monastery donated by the King's servants at the time. The approaching staircases also need repair along with the veranda works. The staircase to the south of the building is original but quite damaged. It is important for it to be reconstructed according to the original design of the staircase. The two staircases on the north side of the building should also be repaired in accordance with the original design. In addition, damaged roofs that weaken the physical strength of the building must be replaced. The roof structures under the roofing sheets must also be inspected in detail. The above-mentioned conservation work should be carried out in the dry season. After that, wood floral motifs and wood sculptures that enhance the value of the building need to be maintained after the necessary repairs for physical strength have been made. The wood floral motifs and sculptures are often left untreated for years and has accumulated dirt over time. These impurities cause harm to the original appearance of the wood carvings. When cleaning these contaminants, only non-destructive methods must be used. Wood carvings that were destroyed and lost must be replaced and restored like their original appearance.
