Disaster Risks of the Seven Filipino-Spanish Churches of the Diocese of Maasin, Philippines

Raffy Andrew G. Loreto¹, Guiraldo C.
Fernandez, Jr.², Leslie Anne L. Liwanag²,
and F.P.A. Demeterio III³

¹Department of Civil Engineering, Visayas State
University Baybay City, Philippines

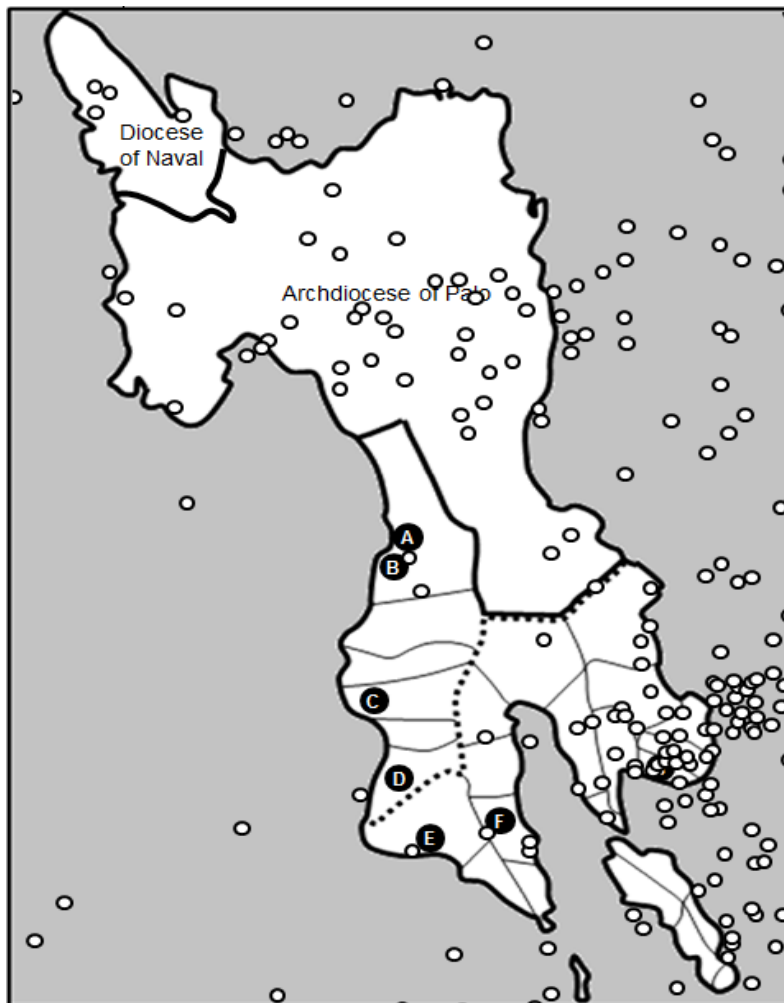
Building on Yu, Oreta, and Eng’s methodology, in profiling the earthquake hazard, three specific approaches were used by this paper (Yu, Oreta, and Eng 2014). First was the location of the seven heritage churches relative to the plot of earthquake epicenters using Project NOAH’s “USGS Historical” model as shown in Figure 4. This “USGS Historical” model operates on the data from the United States Geological Survey that recorded at least 3.0 magnitude earthquakes from 1907 to 2017.

Fig. 4 Approximate Positions of the Seven Filipino-Spanish Churches of the Diocese of Maasin Relative to the Historical Epicenters of Earthquakes in the Island of Leyte according to the “USGS Historical” Model of Project NOAH.

The two general clusters of historical epicenters of earthquakes appear to correlate with the locations of the island’s three active and potentially active volcanos, namely: Mount Cabalian, located on the southwestern end of the island of Leyte, Mount Cancajanag, and Mount Mahagnao, located near the middle section of the same island. This first approach was accomplished by visually inspecting whether each of the seven heritage churches are somewhere near to these two discernible clusters of epicenters of historical tremors. Table 3 provides the numerical scores and their corresponding verbal interpretations that were used for this first approach.

Historical Epicenters of Earthquakes in the Island of Leyte: Based on Figure 4, Table 11 summarizes the earthquake hazards for the seven heritage churches and their proximity to the clusters of historical epicenters of earthquakes in the island of Leyte, and as given their corresponding numerical scorings and verbal interpretations based on Table 3.

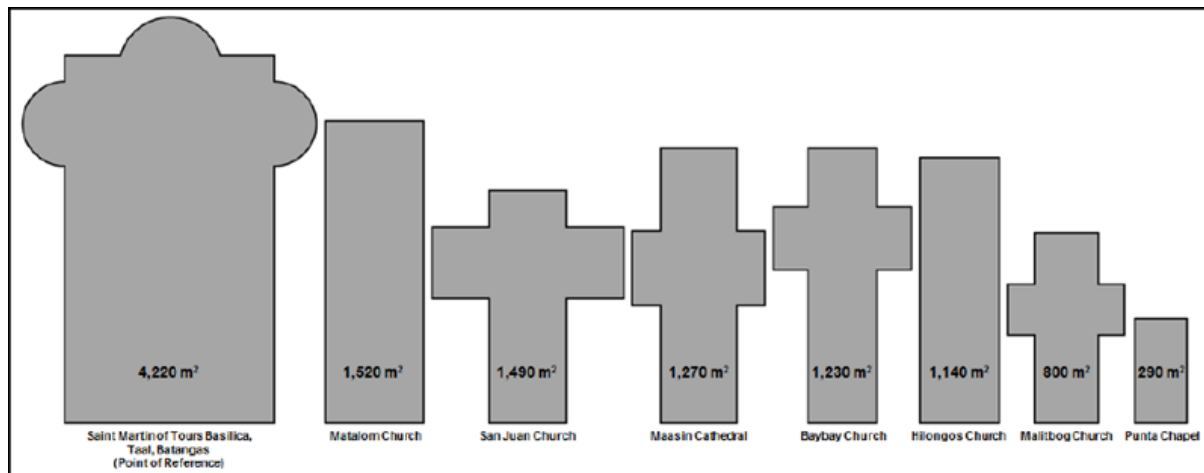
Figure 6 presents the rough calculated size of each of the seven Filipino-Spanish churches, based on scaled satellite images from Google Earth, compared to Saint Martin of Tours Basilica, in Taal, Batangas, which is reputed to be the largest church in the Philippines.

Fig. 6 Rough Calculations of the Sizes of the Seven Filipino-Spanish Churches based on Scaled Satellite Images from Google Earth and Relative to the Size of the Saint Martin of Tours Basilica, Taal, Batangas, the Philippines' Largest Church.

In Figure 6, Hilongos Church represents its rough size prior to its burning by the Americans in 1901. Hilongos Church is counted as an existing Filipino-Spanish church because its old façade and bell tower are still standing and integrated into the 1968 re-oriented structure. In this paper, San Juan and Matalom Churches are considered relatively large churches; Baybay, Maasin, and Hilongos Churches as relatively medium sized churches; and Malitbog Church and Punta Chapel are considered small churches that are low in height profile compared to the other churches. Aside from its sizes, some notable features for some of the churches were identified. Unique to Hilongos, Maasin, Baybay, and San Juan churches is the presence of buttresses on their walls that add structural stability and support during movement. Another notable feature unique to Baybay, Maasin, and Matalom Churches is the octagonal dome over the crossing between the nave and transepts. Baybay Church has an octagonal wooden dome, while Maasin Church has a semi-circular and bigger dome, but this is covered by a pyramidal roofing system. Malitbog Church has a smaller octagonal dome, with an octagonal lantern that is largely visible from the outside.

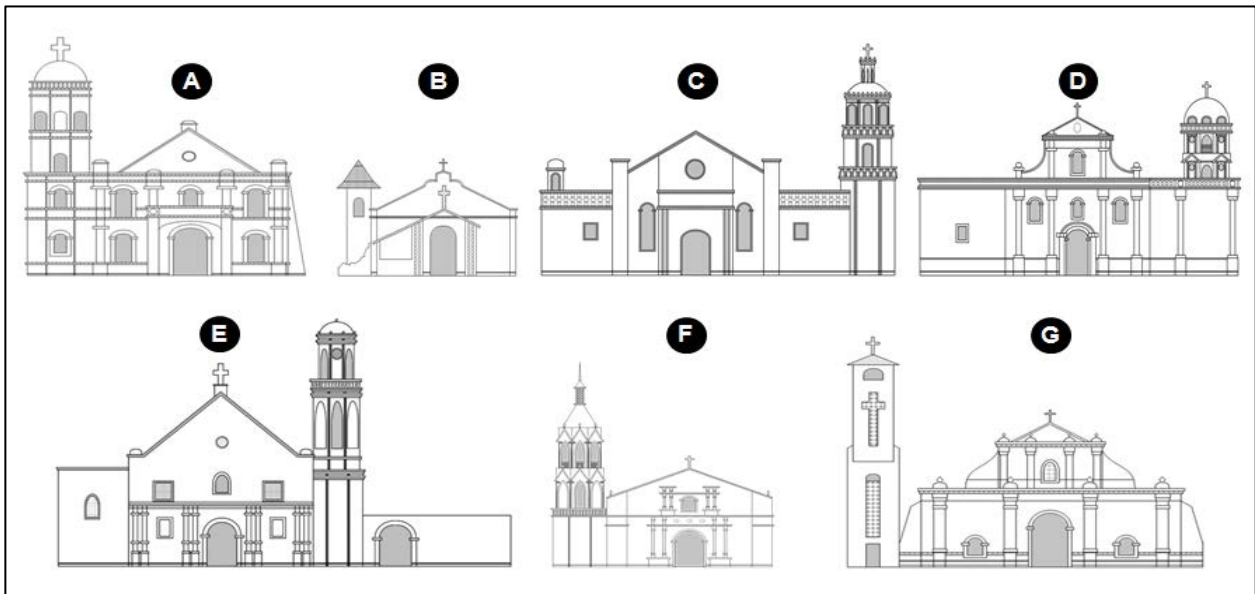
In term of materials and methods used in construction, Punta Chapel's side walls had been extended upwards using stone and concrete. Originally, it probably was only about a meter tall, with the remaining height covered with other lighter materials such as the local wattle and daub, called *tabique Pampango*, or boards, or woven bamboo slats. The load bearing walls of the other six heritage structures are made of rubble and lime mortar construction called *mamposteria*. Except for the rudimentary stonework of Punta Chapel, all of the other six churches are clad with finely cut coral stones, called *cal y canto*. Contrary to popular beliefs, these churches are not made of stone blocks, as these visible stones actually look like thick tiles rather than blocks that cover the *mamposteria*. Figure 7 presents drawings of the façades of these seven heritage churches.

Fig. 7 Drawings of the Façades of (A) Baybay, (B) Punta, (C) Hilongos, (D) Matalom, (E) Maasin, (F) Malitbog, and (G) San Juan Churches.
